# Magnetic hazards at heliports

## RISK MITIGATION STRATEGIES

So, North is which way? Rex J Alexander, board member and past president of the US National EMS Pilots Association, discusses the problems that can be caused by magnetic disturbances associated with rooftop and ground level helipads, and the simple steps that can be taken to alert pilots to the dangers

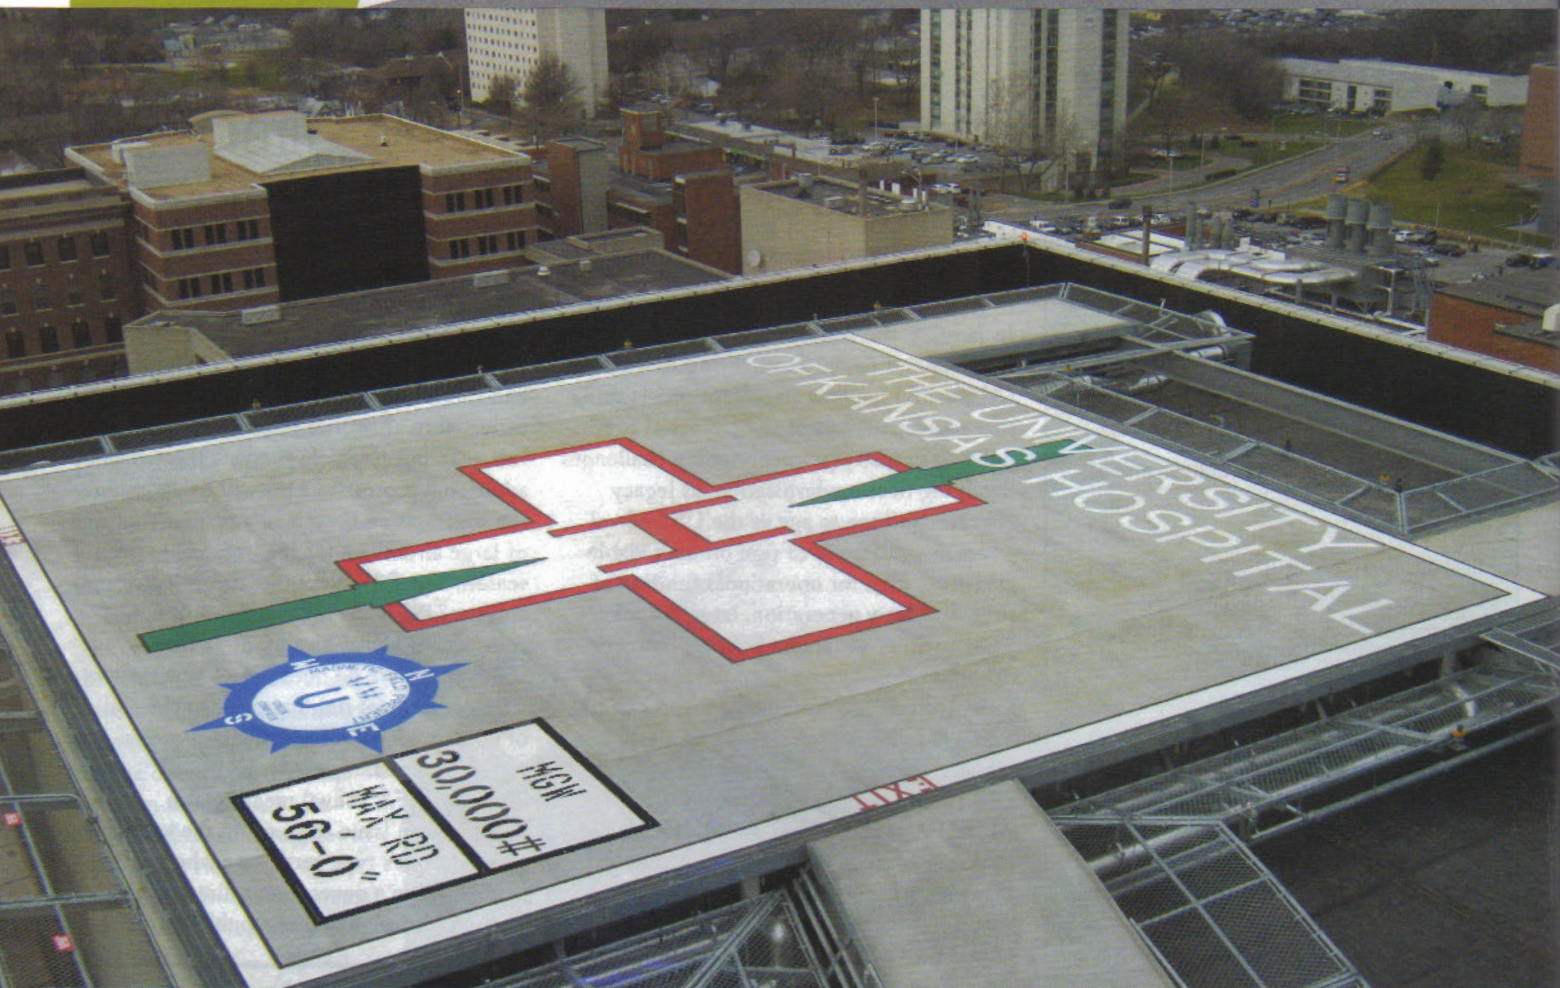
### The hazard marking as it appears at the University of Kansas Hospital

two particular colours. By painting the symbol directly onto a heliport's TLOF (Touchdown and Lift-off area) or FATO (Final Approach and Take-off area), identification from altitude from every angle is ensured and does not introduce a vertical hazard to the flight environment.

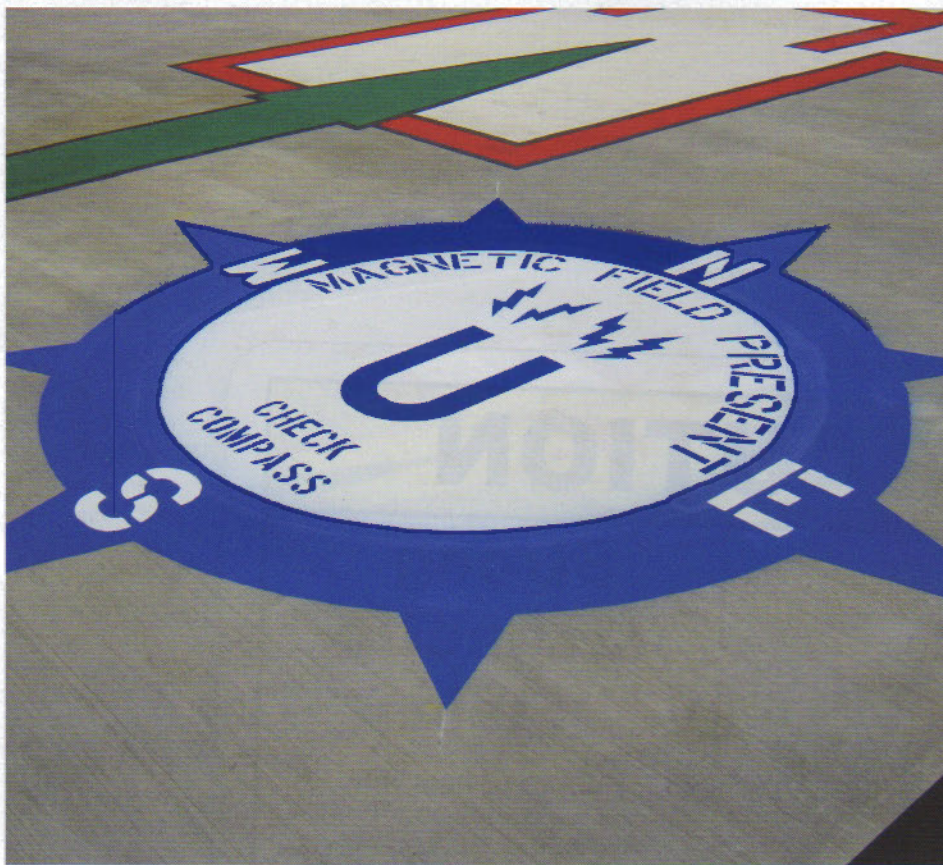
*Top left:* An intuitive hazard marking created by combining a modified compass rose design with the standard hazardous material labelling symbol used to identify magnetic hazards for shipping  
*Left:* Where disproportionate EMI is suspected, a hand held electronic meter that measures different types of magnetic energy can be very effective

The ultimate goal in creating any good hazard or warning marking is to create one that is intuitive to understand and is visible from a distance at every possible angle. Today's heliport markings also need to be apparent and clearly discernible during day, night and NVG operations as well. This particular hazard marking needs to be located on or very near the heliport landing area itself, while at the same time not introducing a vertical hazard into the operational environment. An intuitive hazard marking to alert pilots to excessive amounts of magnetic interference was ultimately created by combining two symbols most pilots are already familiar with, these being a modified compass rose design, similar to the ones found at many airports, along with the standard hazardous material labelling symbol used to identify magnetic hazards for shipping. In using the blue and white colour schemes indicative of both of these symbols, not only was the original familiarity maintained, but an NVG-friendly marking was also achieved due to the 'albedo' (reflective coefficient) differential between these
